Chapter 2

Site Assessment

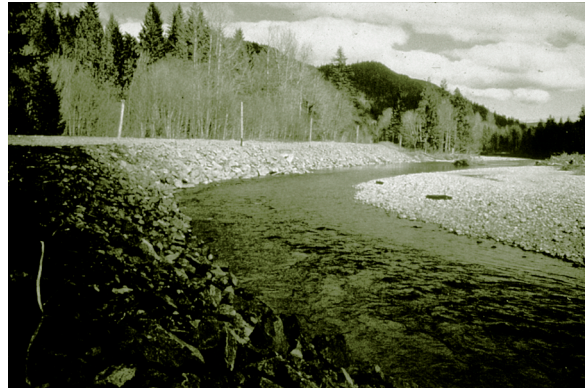
Figure 2-3. Smoothed channel.

- Smoothed channel: This is a channel in which roughness elements have been removed, creating a channel with a reduced resistance to flow. Smoothed channels occur where woody debris has been removed, the channel has been dredged, or the streambank has been hardened (see Figure 2-3). Once a channel is smoothed, it will have excess energy that is dissipated on the streambed and banks. The channel will adjust itself to dissipate this energy by increasing its channel
